**ANALYSIS OF THE  
BIOPHYSICAL-CHEMICAL  
PARAMETERS OF THE  
BENFICA RIVER IN THE  
MUNICIPALITY OF  
BENEVIDES, STATE OF  
PARÁ (BRAZIL) – 2025**

Ciências Exatas e da Terra, Ciências Biológicas • 06/07/2026

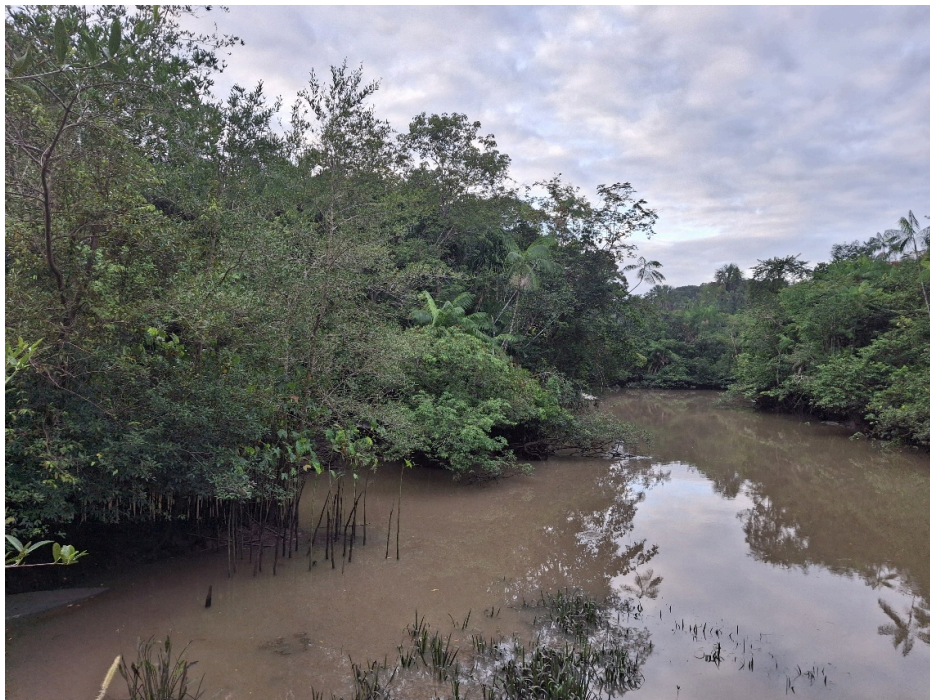
Benfica river at low tide. Photo by Aureliano da S. Guedes, PhD

The brown colour of the water of Benfica River in the stretch within the Benfica district reflects the presence of sediments carried from the riverbanks by leaching from Amazonian rains and the current that acts by lifting and carrying sediments along its course.

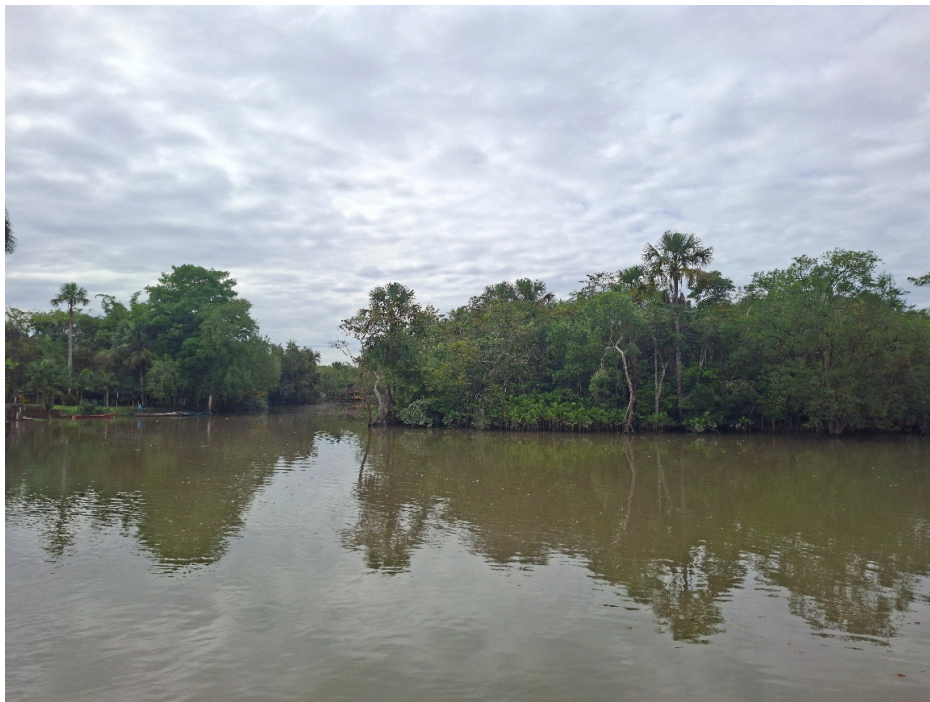
Benfica river at high tide. Photo by Aureliano da S. Guedes II.

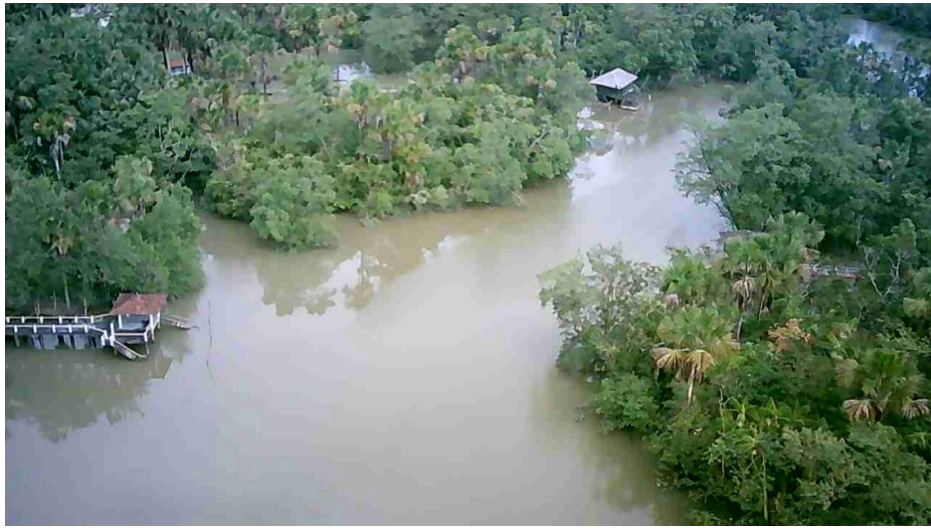
Aerial photo of Benfica river at high tide with emphasis on the ciliary forest.

As for flora, several species were observed, including: *Bactris gasipaes*, *Bertholletia excelsa*, *Carapa guianensis*, Aubl, *Caladium bicolor*, *Carica papaya*, *Capsicum chinense*, *Cedrela fissilis*, *Ceiba pentandra*, *Copaifera langsdorffii*, *Euterpe oleracea*, *Heliconia bihai*, *Hevea brasiliensis* L, *Mauritia flexuosa*, *Montrichardia linifera*, *Spondias mombin*, *Swietenia macrophylla*, *Symphonia globulifera*, *Vouacapoua americana*, among others.
